# CO-OP GAS & SUPPLY COMPLEX GRANARY BUILDING FEASIBILITY STUDY

Prepared for the Bonner County Historical Society by  
Clark & Chapin Architects  
Suarez Engineering  
Artifacts, Inc. Historical Consultants

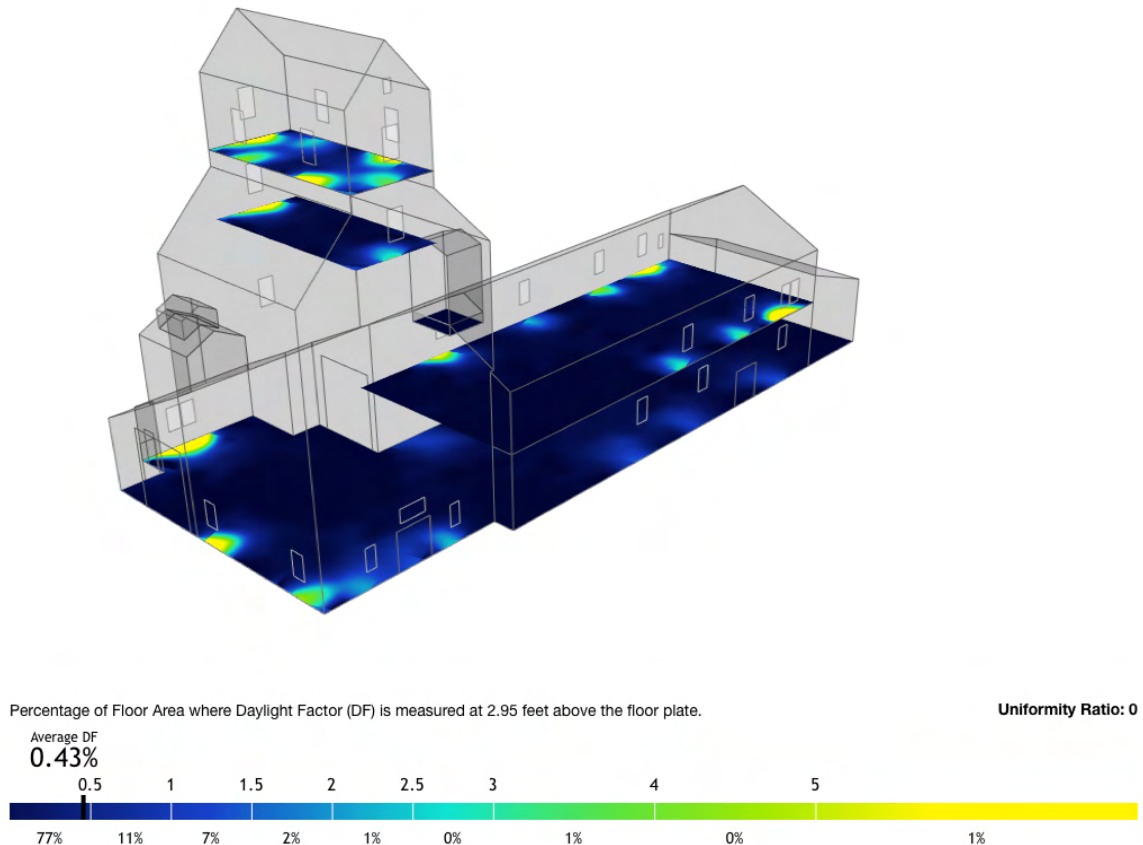
**Figure 6.** Daylighting assessment of the existing building. Note significant amounts of the building have very low access to natural daylighting, indicated by the dark blue tones. The “Daylight Factor” is a figure used to assess the daylight inside a structure as compared to available daylight outside. For reference, a LEED certified project will typically attain a daylight factor of at least 2% across a minimum of 50% of the building floor area.

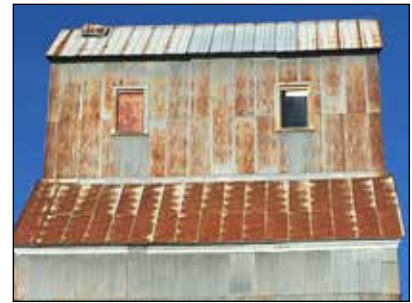
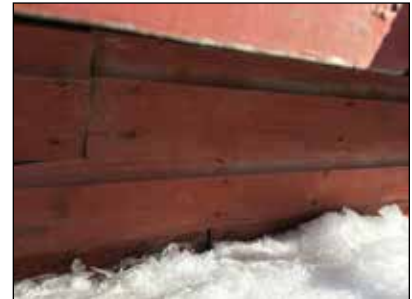
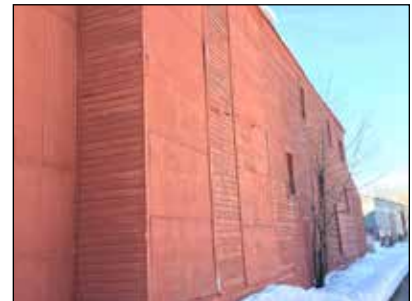
- The outline of a former gable roof addition off the north side of the main granary volume remains evident.
- Vents added along the lower level of the processing portion.
- Horizontal wood and vertical metal cladding at shed roof north addition.
- Plywood replacement sections on the south end of the east facade of the processing building.
- Loss of cladding during wind storms (preservation of the cladding will include recommendations from the architectural/structural report to address the current state of cladding attachment).

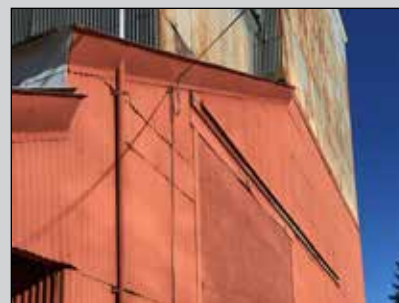
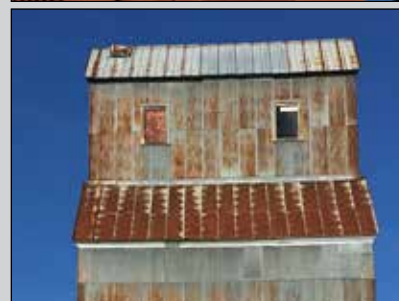
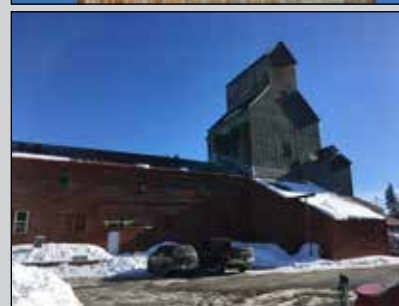
- Southeast portion of the gable roof over the two story processing portion, sheathing replaced with plywood and rafter replaced.
- Roof bracing received added members nailed to face of bottom chord.
- Ridge vent in processing portion removed and the opening closed off.
- Added shed roof with exposed rafter ends off the north end of the building.
- Loss of metal roofing during wind storms (preservation of the roofing will include recommendations from the architectural/structural report to address the current state of attachment).

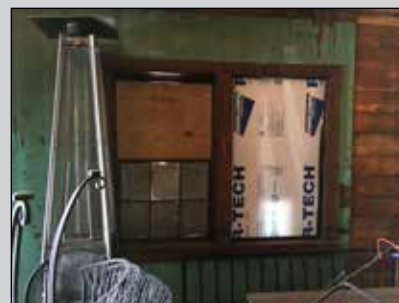
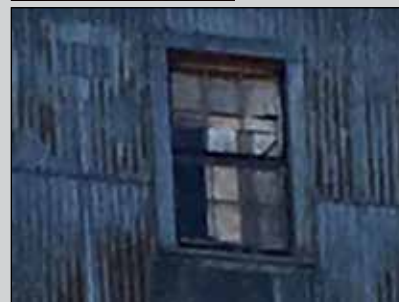
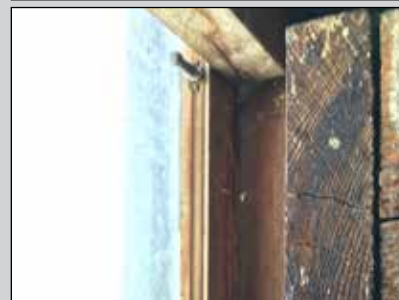
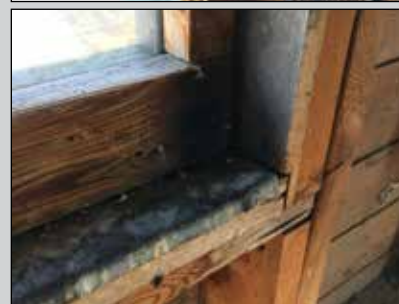
- Boarded over windows in the granary portion at all levels.
- Missing glass and added plywood at the office windows.
- Replacement and missing sash at all of the processing windows.

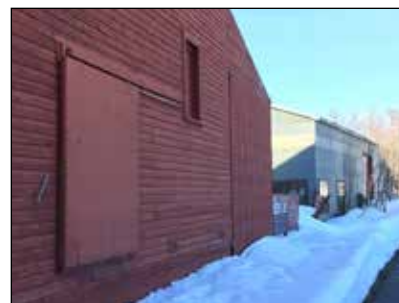
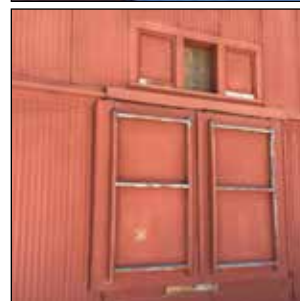
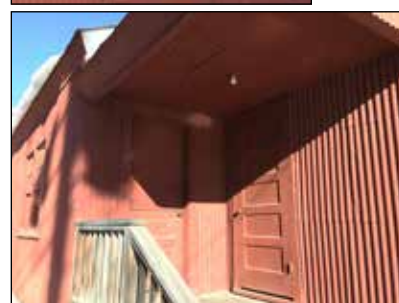
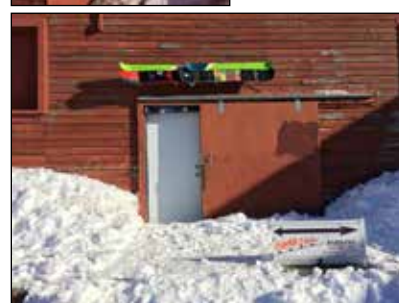
- Plywood added at former doors.
- South doorway at the pass through replaced with new wood framing and oriented strand board cladding.
- North doorway at the pass through replaced with new wood framing and plywood cladding.

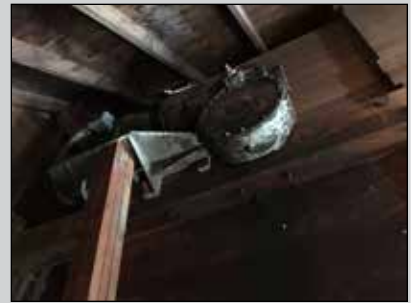
- Contemporary wiring added within the processing building relating to contemporary use of the building.
- New lighting fixtures throughout the processing space.

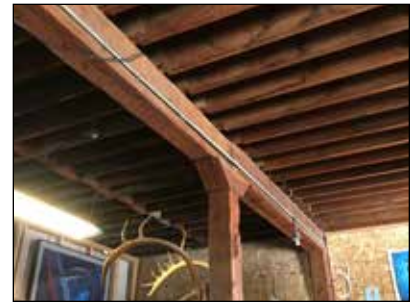
- New wall framing at the south end of the space, the addition of a new beam and post, new ceiling and wall paneling, and plywood over the original floor boards.
- Removal of equipment from the concrete pad.
- New wall framing enclosing an office along the west side of the volume.
- Exterior doorways and windows along the east side closed off.
- Window closed off along the west side of the volume.
- New hand railings at the stairs.
- All new lighting fixtures.

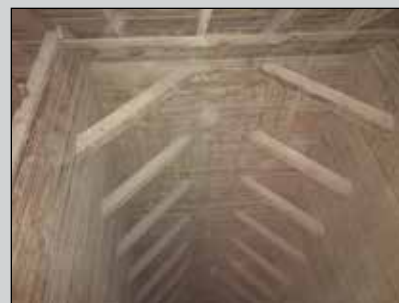
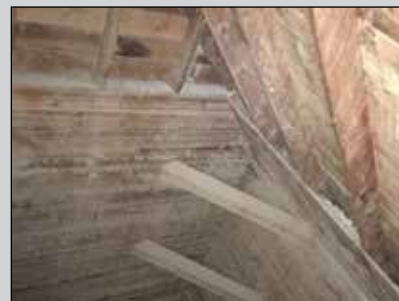
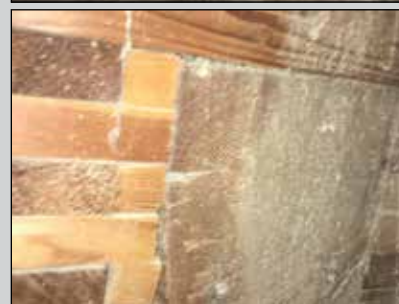
- Framing repairs due to failed conditions in the upper southeast corner of the outer bin.
- Refer to the architectural/structural engineering report for details on conditions, including the remaining deteriorated portions of bin walls, primarily on the south facade.

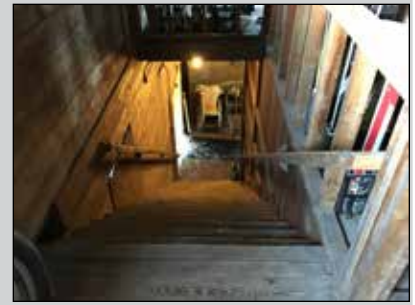
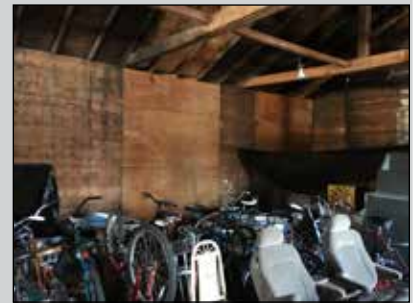
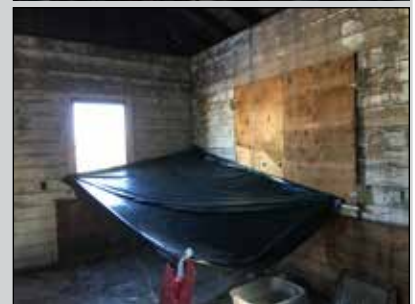
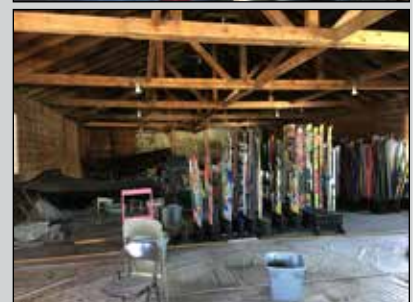
- New beam framing added in the south end to stabilize the rooftop enclosure structure.
- New lighting system installed throughout the space.
- Stored items throughout the space.
- Added wood railing around the stairwell opening.

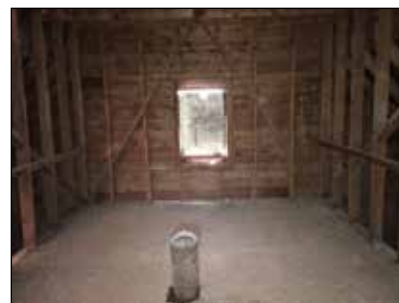
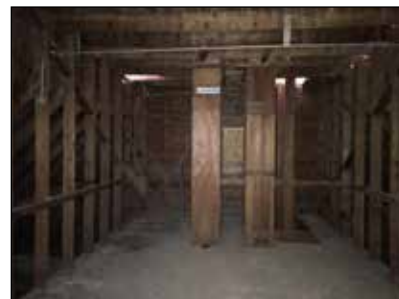
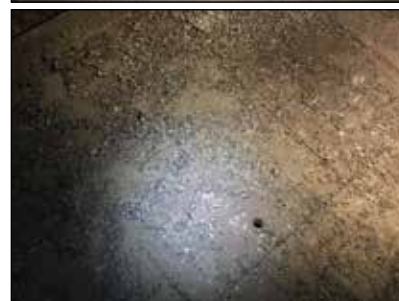
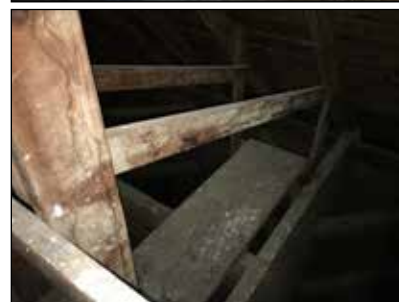
- Missing window sash at east and west end.

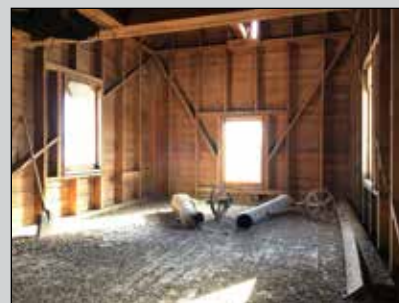
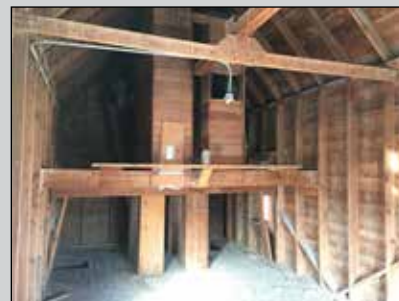
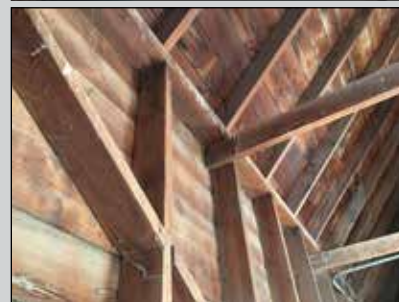
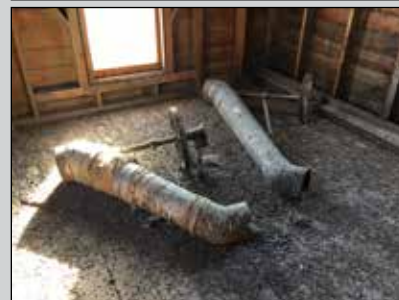
- Added boards and plexiglass at windows, oriented strand board infill at south-west window.
- Pigeon guano throughout space.
- Flooring in east portion added to cover over former openings to floor below.
