# CO-OP GAS & SUPPLY COMPLEX GRANARY BUILDING FEASIBILITY STUDY

Prepared for the Bonner County Historical Society by  
Clark & Chapin Architects  
Suarez Engineering  
Artifacts, Inc. Historical Consultants

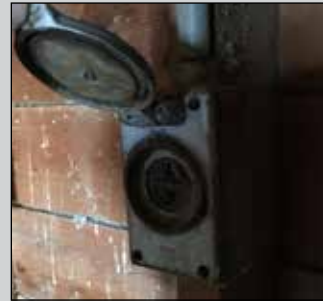
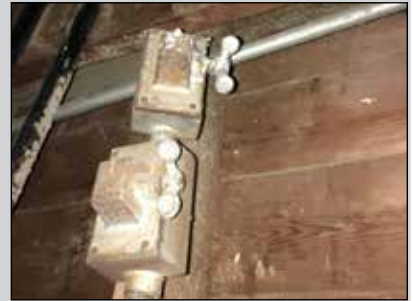
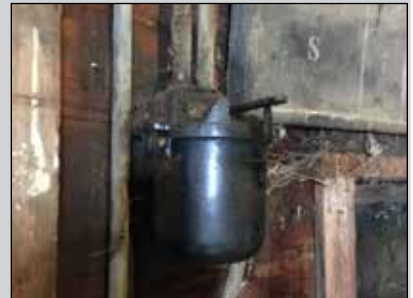
- Contemporary wiring added within the processing building relating to contemporary use of the building.
- New lighting fixtures throughout the processing space.

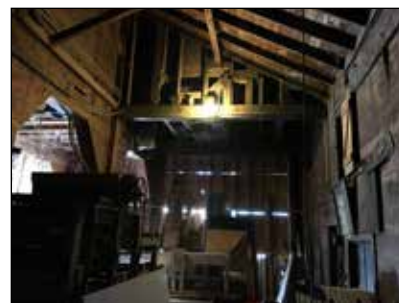
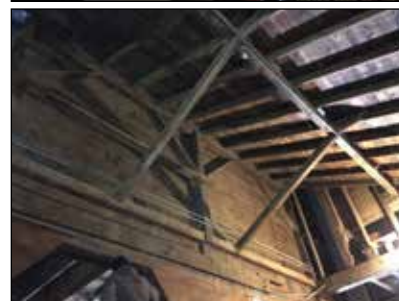
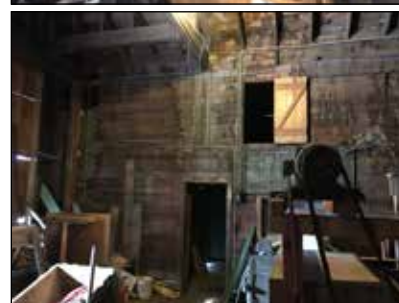
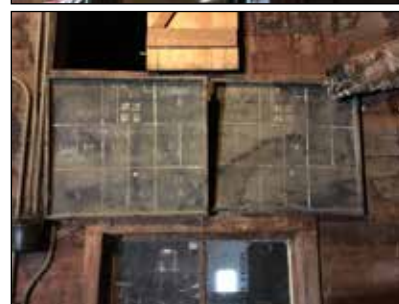
## Level 1 | Pass Through, Loading

- Removed tongue and groove ceiling at the south end above the chaff separator.
- East end added partition wall and insulation to close off a work space for the tenant in the processing portion of Level 1, and added oriented strand board cladding and a partition in the northeast corner of the space.
- Added posts at the south end of the pass through providing additional support at the south pass through entrance.
- Bucket lift chase cut off at this level and lower portions of metal distribution pipes for grain also removed.
- Variety of contemporary and historic materials stored in this space.

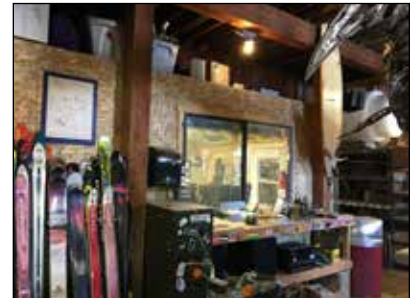
- New wall framing at the south end of the space, the addition of a new beam and post, new ceiling and wall paneling, and plywood over the original floor boards.
- Removal of equipment from the concrete pad.
- New wall framing enclosing an office along the west side of the volume.
- Exterior doorways and windows along the east side closed off.
- Window closed off along the west side of the volume.
- New hand railings at the stairs.
- All new lighting fixtures.

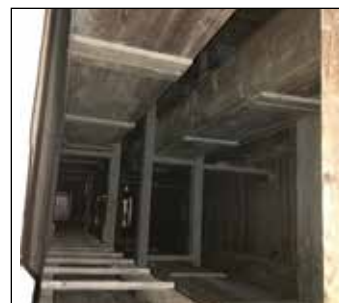
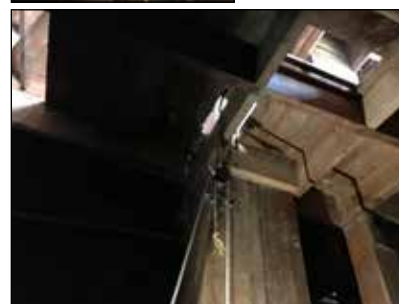
- Lower portions of the grain elevators at level 1 cut off and the bottom boots removed.
- Lower ladder portion removed; current access relies on an aluminum ladder resting against the base of the wood ladder for access to level 2.
- West facade window boarded over.
